METER ERROR REPORT**FINAL**

SITE NAME	LANGHOLM OFFTAKE
LDZ	SCOTLAND
LAST GOOD DATE	
START DATE	7.11.05
END DATE	10.11.09
SIZE OF ERROR (No reconciliation required if under 0.1%)	1.3% under registration
ESTIMATE – Y/N?	Y
ROOT CAUSE	Turbine meter calibration shift
ANALYSIS	
METER TYPE	Turbine
AUTHOR	T Roberts
CHECKED BY	S Howells

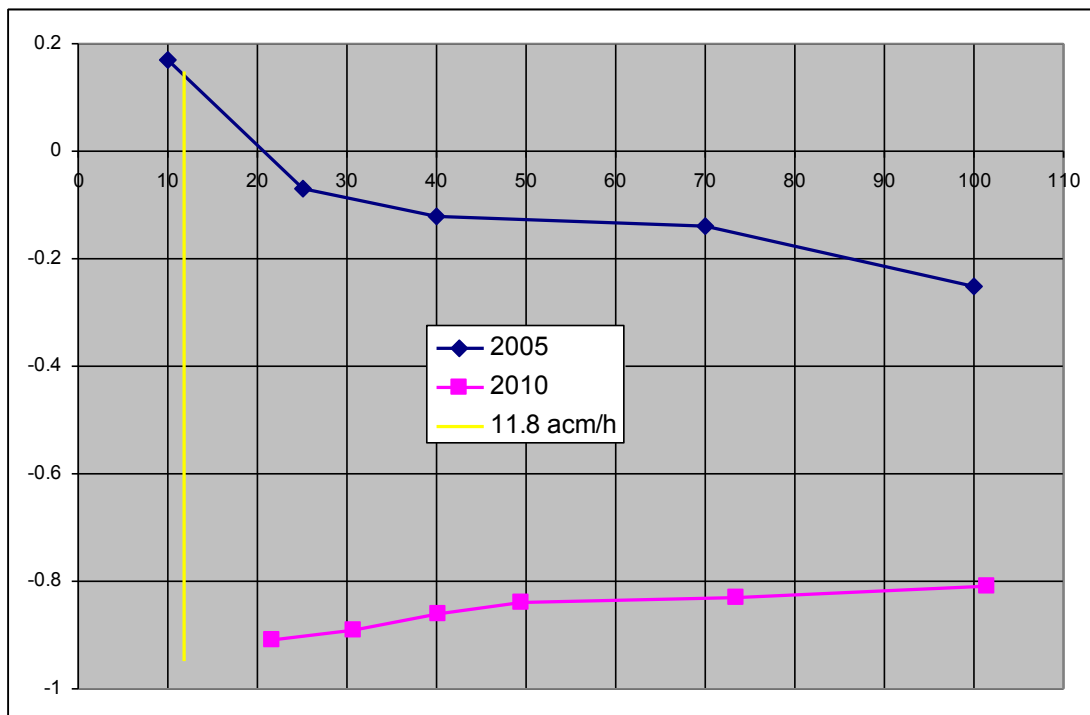
The calibration curves applicable before meter installation in 2005 (NMI) and after replacement in 2009 (GL) are plotted below. The additional line at 11.8 acm/h is based on the maximum frequency from the meter recorded in HPMIS over the period in question, with typical flowrates being well below 10acm/h.

As the operational flowrate is substantially below the minimum points of both 2005 and 2010 calibrations, it is not possible to accurately calculate a correction for errors resulting from the shift in calibration.

During a combined ME2 and metering audit in November 2008 a slight mechanical noise from the meter was noted during spin-down testing, although the turbine ran freely with no sign of damage. Consequently the audit report recommended replacement of the meter which was carried out in November 2009. It is likely that deterioration of the turbine bearings caused the shift in calibration.

It is not recommended that any reconciliation is attempted as the site operates below the calibrated range of the meter.

A review is required to establish a closer match between the range of site operational flowrates and meter capacity. Availability of a spare meter would also allow possibly faulty meters to be removed for service and calibration.
