METER ERROR REPORT**FINAL**

SITE NAME	FARNINGHAM
LDZ	SOUTHEAST
START DATE (actual)	30/10/08
LAST GOOD DATE	
END DATE	24/6/09
SIZE OF ERROR (No reconciliation required if under 0.1%)	< 0.5%
ESTIMATE – Y/N?	N
ROOT CAUSE	CONTAMINATED ORIFICE PLATE
ANALYSIS	
METER TYPE	ORIFICE
AUTHOR	T Roberts
CHECKED BY	B Purl

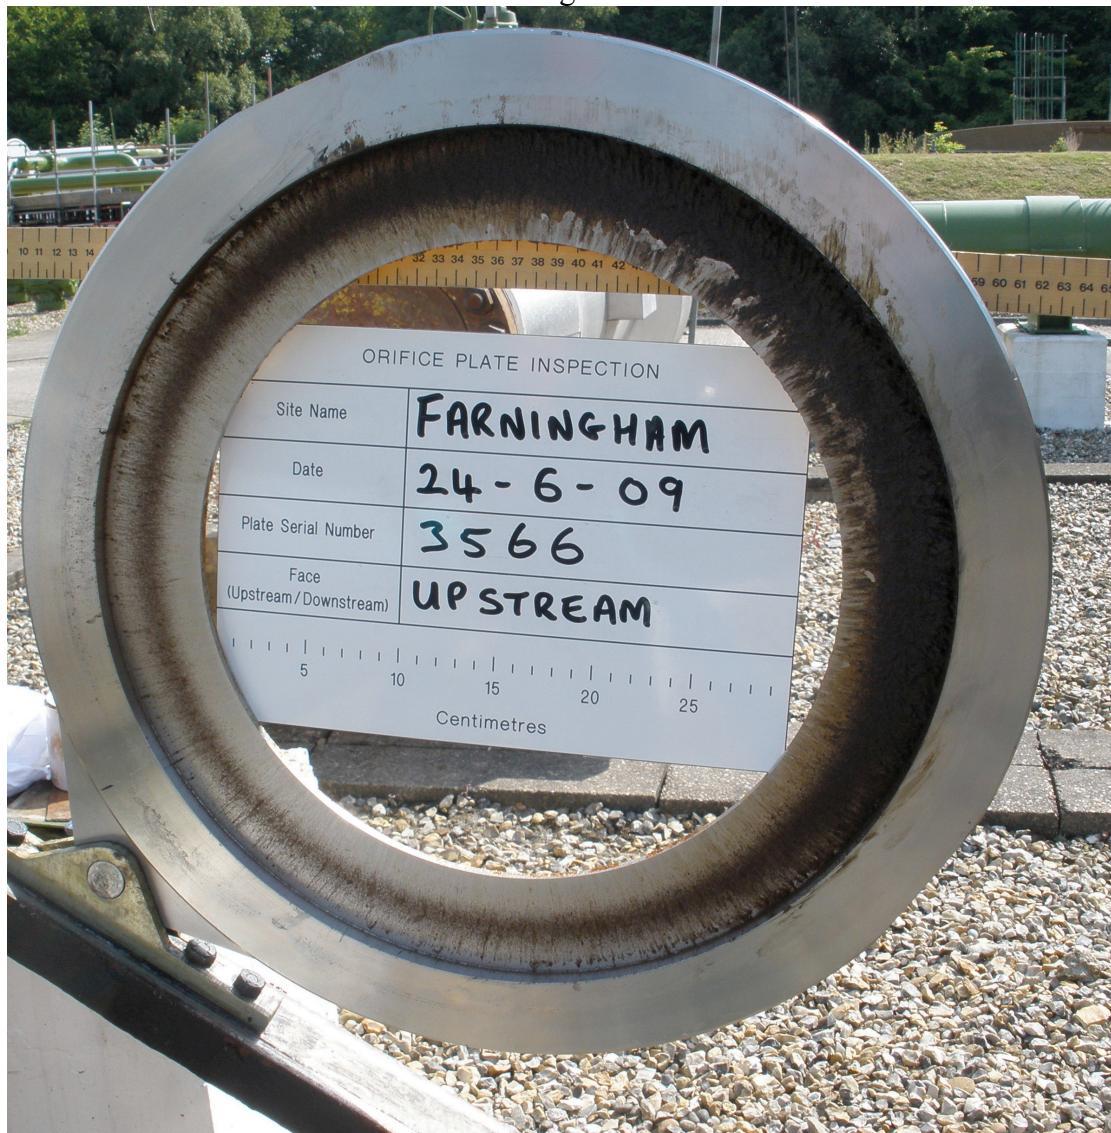
Fig1

The meter system underwent its annual ME2 metering revalidation in June 2009 when it was noted that the orifice plate upstream face had heavy contamination on the lower part of the upstream face. The contamination was recorded in a digital photograph (see Appendix A fig 1).

The assessment of <0.5% under registration has been made with reference to PD ISO/TR 12767:2007 table 6 where the smallest error recorded during experimentation was 0.5%. The contamination pattern exhibited in Appendix A does not form part of the experimental results in the standard and it's effect is therefore unquantifiable.

The likely cause of the contamination is excess flushing agent and grease from valve maintenance upstream of the meter tube.

The contaminated orifice plate was replaced in rotation with a clean plate.

Orifice plate inspections at Farningham should be carried out quarterly until such time as excessive contamination is not evident.

Maintenance and operations personnel have been reminded of the need to minimize the use of grease flushing agents and grease itself during valve maintenance work. More discussion would be beneficial to identify and eliminate the specific cause of contamination in this case.
