NULL METER ERROR REPORT**FINAL**

SITE NAME	FARNINGHAM
LDZ	SOUTHEAST
START DATE (actual)	30/10/08
LAST GOOD DATE	
END DATE	24/6/09
SIZE OF ERROR (No reconciliation required if under 0.1%)	< 0.5%
ESTIMATE – Y/N?	N
ROOT CAUSE	CONTAMINATED ORIFICE PLATE
ANALYSIS	
METER TYPE	ORIFICE
AUTHOR	T Roberts
CHECKED BY	B Purl

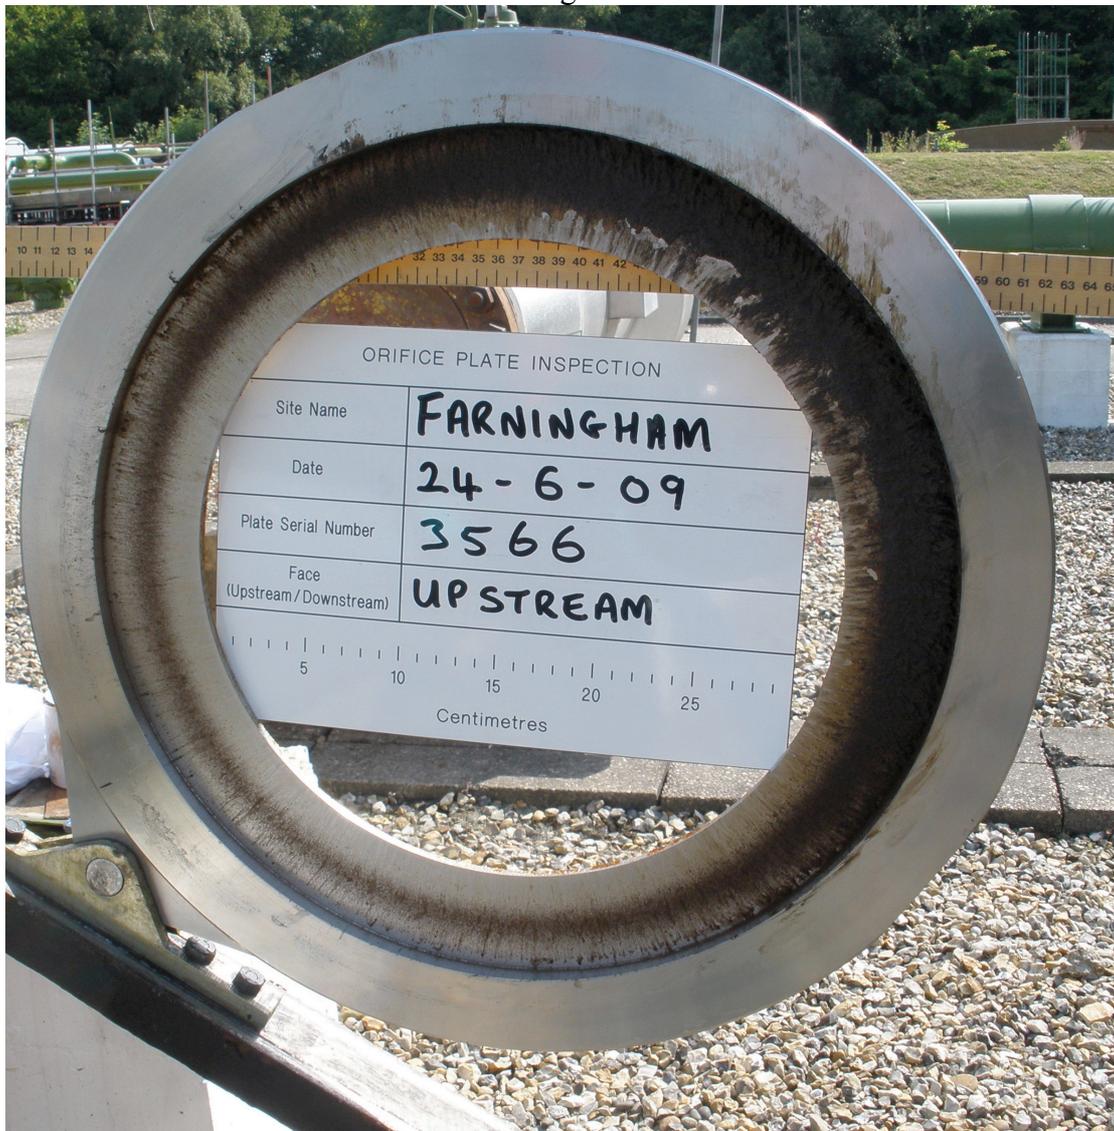
Fig1

The meter system underwent its annual ME2 metering revalidation in June 2009 when it was noted that the orifice plate upstream face had heavy contamination on the lower part of the upstream face. The contamination was recorded in a digital photograph (see Appendix A fig 1).

The assessment of <0.5% under registration has been made with reference to PD ISO/TR 12767:2007 table 6 where the smallest error recorded during experimentation was 0.5%. The contamination pattern exhibited in Appendix A does not form part of the experimental results in the standard and it's effect is therefore unquantifiable.

The likely cause of the contamination is excess flushing agent and grease from valve maintenance upstream of the meter tube.

The contaminated orifice plate was replaced in rotation with a clean plate.

Orifice plate inspections at Farningham should be carried out quarterly until such time as excessive contamination is not evident.

Maintenance and operations personnel have been reminded of the need to minimize the use of grease flushing agents and grease itself during valve maintenance work. More discussion would be beneficial to identify and eliminate the specific cause of contamination in this case.
