**NULL METER ERROR REPORT****FINAL**

SITE NAME	SHORNE OFFTAKE
LDZ	SOUTHEAST
LAST GOOD DATE	N/A
START DATE	N/A
END DATE	N/A
SIZE OF ERROR (No reconciliation required if under 0.1%)	< 0.1%
ESTIMATE – Y/N?	N/A
ROOT CAUSE	ME2 CALIBRATION FAILURE
ANALYSIS	IN REPORT
METER TYPE	ORIFICE
AUTHOR	T Roberts
CHECKED BY	S Howells

# Shorne MER SE003 R2.0

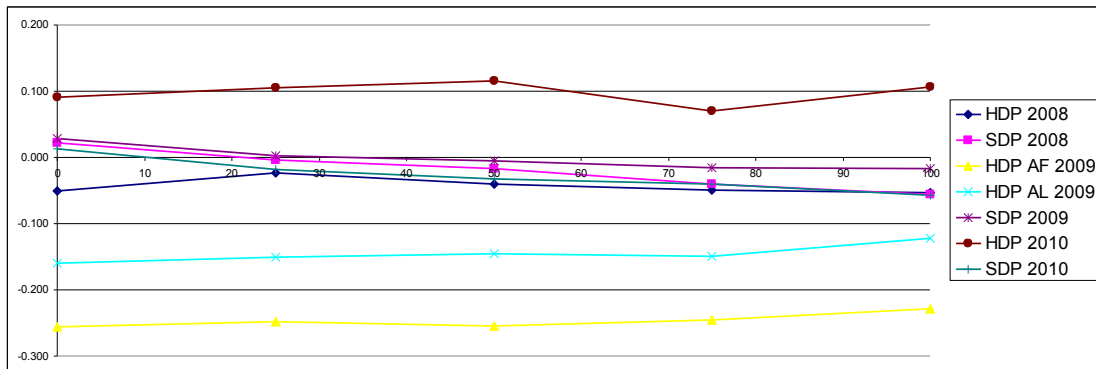
ME2 calibrations : X axis = input % Y axis = error % fsd

Results from the ME2 calibrations of the HDP transmitter in 2008, 2009, and 2010 have been plotted below. In 2008 both HDP and SDP are well within the ME2 tolerance of +/- 0.2% fsd. The 2009 HDP A/F errors of around -0.25% fsd can be seen to have been adjusted A/L to around -0.15%. In 2010 the HDP A/F error is around +0.1% fsd.

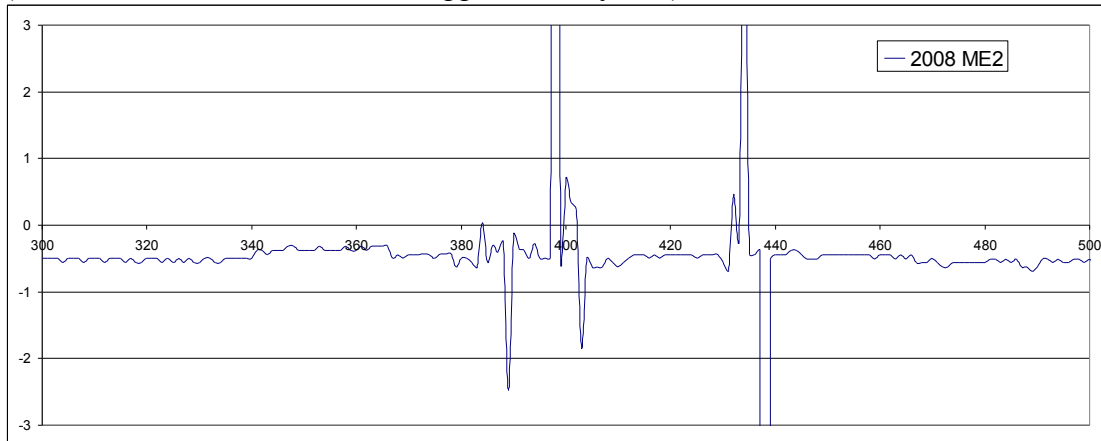
2008 ME2 RBD data : X axis = time Y axis = HDP-SDP mbar  
(Calibration date of 15/7/2008 at approximately 400)

The 2008 RBD data plot illustrates that the difference between the HDP and SDP results was well within tolerance.

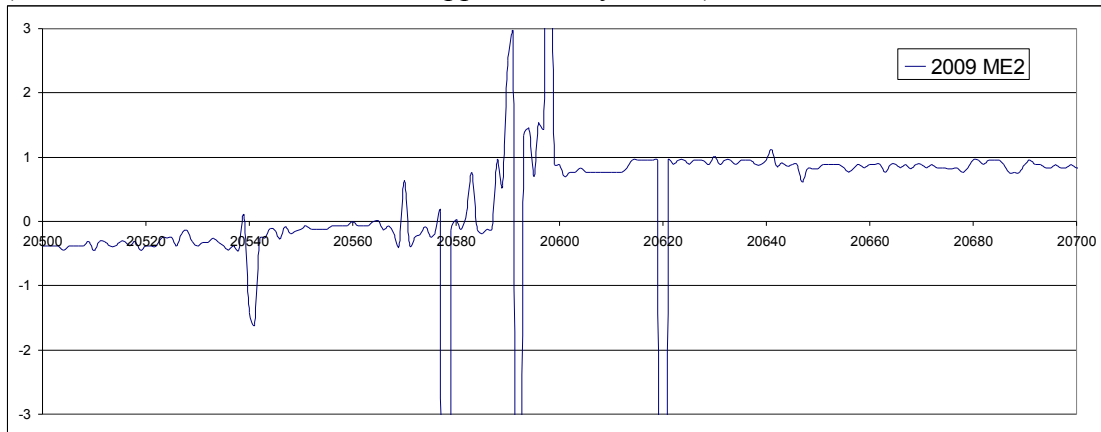
2009 ME2 RBD data : X axis = time Y axis = HDP-SDP mbar  
(Calibration date of 14/7/2009 at approximately 20590)

The 2009 RBD data plot illustrates a difference similar to 2008 before the ME2 calibration, but after adjustment a positive difference of around 1 mbar (0.1% fsd) is evident.

Taking the SDP transmitter as a reference it is concluded that the 2009 A/F and A/L results were not true representations of transmitter performance.

RBD data does not support these errors being present and would suggest that the HDP transmitter was in fact well within tolerance in 2009 and the adjustment at that time of around +0.1% fsd actually left the transmitter with an error of around +0.1% fsd.

Unknown, but related to the 2009 ME2 HDP calibration.

Consideration be given where ME2 calibration failures give rise to errors in flowrate in excess of 0.1% to repeating the tests with different personnel and test equipment.

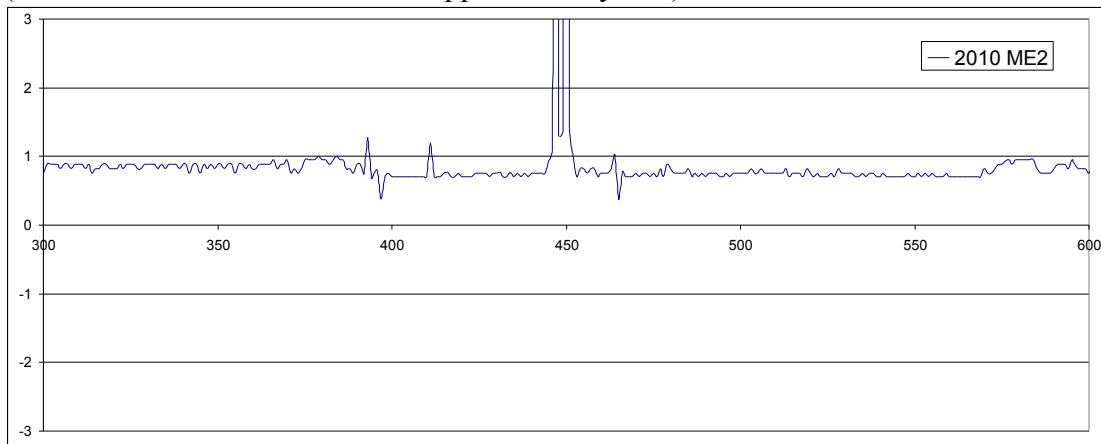
2010 ME2 RBD data : X axis = time Y axis = HDP-SDP mbar  
(Calibration date of 23/7/2010 at approximately 450)

The 2010 RBD data plot illustrates a difference similar to that of the 2009 A/L value.
