METER ERROR REPORT

SITE NAME	Ilchester
LDZ	South West
START DATE (actual)	03rd March 2009 (21:56)
LAST GOOD DATE	
END DATE	04th March 2009 (00:03)
SIZE OF ERROR (No reconciliation required if under 0.1%)	30,376. SCM over registration (equivalent to 2.026%)
ESTIMATE – Y/N?	N
ROOT CAUSE	Pressure transducer locking up
ANALYSIS	HPMIS RBD data
METER TYPE	Orifice Plate
AUTHOR	S Western
CHECKED BY	C Stock

Gas is supplied to part of the South West LDZ, Wales & West Utilities Network, at Ilchester FWACV offtake. The site metering system comprises a single Orifice meter with an isolated bypass.

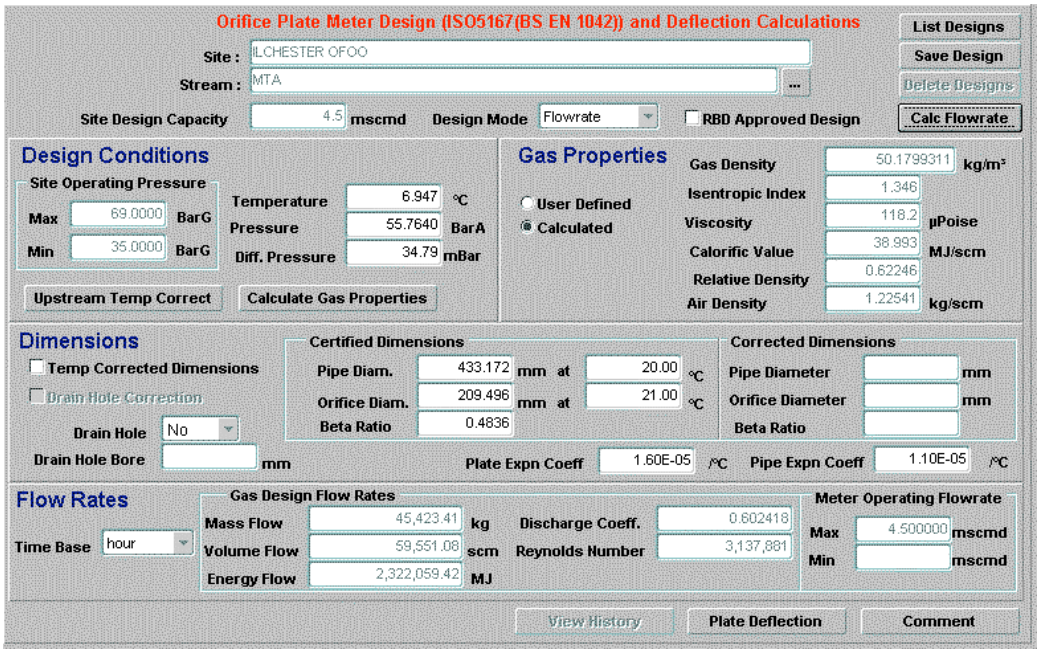
Using the HPMIS orifice plate design calculation (See Fig. 1a & 1b) together with the 8 minute RBD and gas composition data the volume flow for the period where the PT locked was calculated. In each instance, the volume flow for the locked up PT and the estimated PT reading were calculated. By comparing these calculated flows over the period of the PT locking up it was estimated that orifice metering system over-registered 30,376.93scm of gas.

From HPMIS, the Dvol for Gas Day the 03rd of March 2009 was 1.499169mscm so the over-registration equates to 2.026 % of Dvol. A spreadsheet detailing the calculations is available on request.

Fig. 1a - HPMIS screen shot for flow calculation using calculated average pressure

HPMIS (RBD data) should be monitored to identify any such future errors. Should the error re-occur an assessment of the transmitter may be required to ensure its integrity.

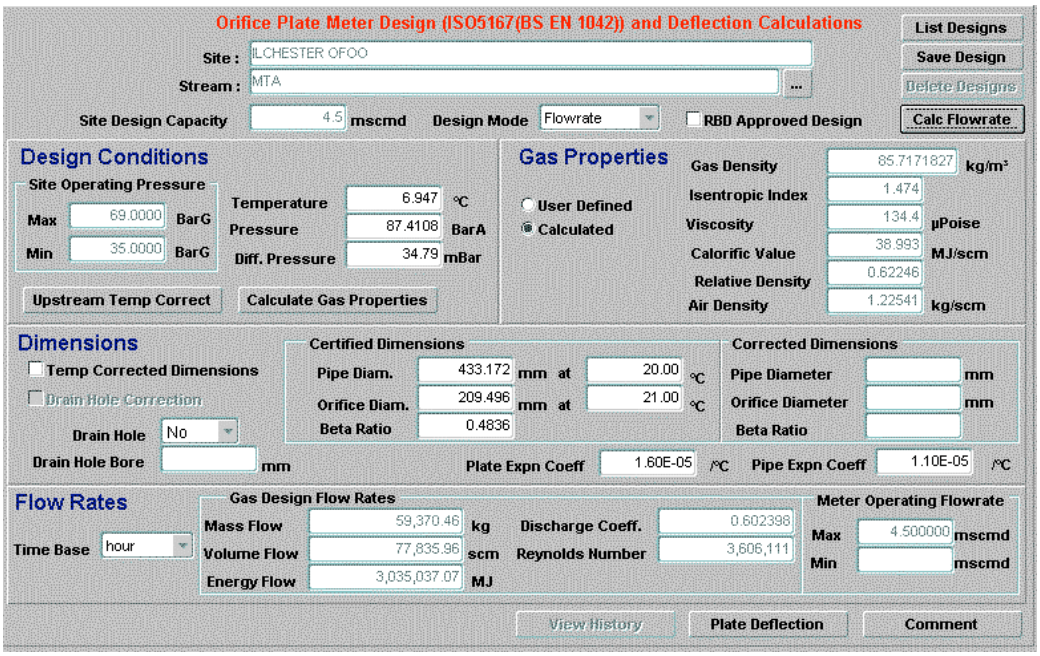
On the 3rd of March 2009 the pressure transducer locked up for some undiscovered reason for a period of 2 hours 7 minutes. This caused the standard flow rate to be incorrectly calculated. The condition was rectified by turning the power to the transmitter off and then on again.

Fig. 1b - HPMIS screen shot for flow calculation using locked pressure value
