Null Report

Air Liquide Biogas Solutions Europe

MER/CAD/237/23 Biodynamic BNEF

Document Reference: NK3244F-002

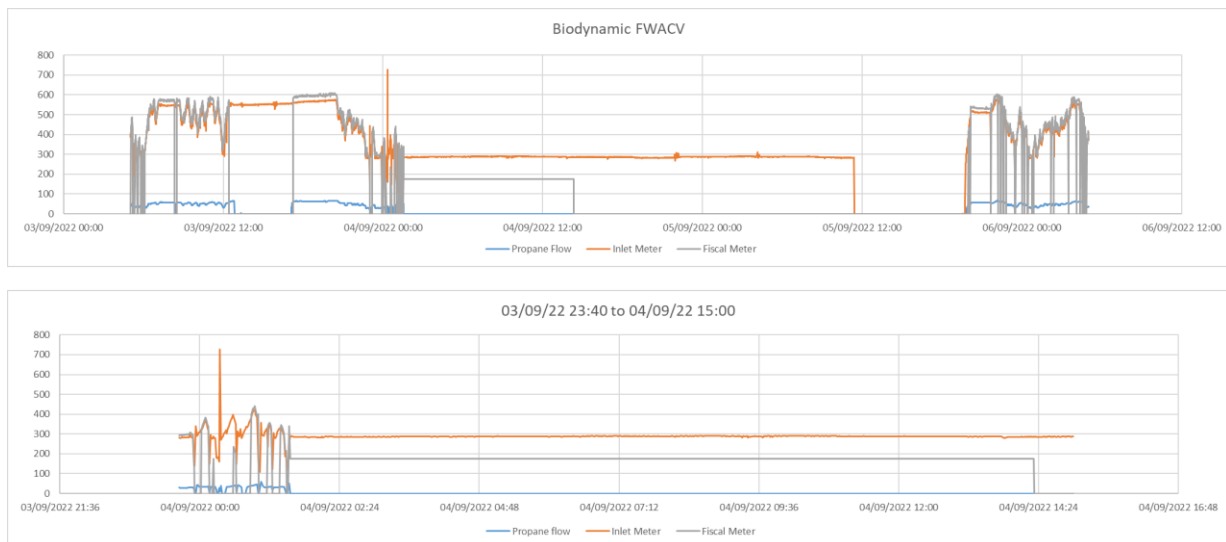
Figure 1 Volume flow rates for Inlet Meter and Fiscal Meter

Over the period of interest, the flowrates on the fiscal meter dropped dramatically indicating the meter system had gone into reject mode. The error consisted of the fiscal meter reading high for a period of 768 minutes.

The calculation is a sum of the Fiscal Meter total volume flow for the affected time period in Sm³, split into two time periods, one for each gas day mentioned. These calculated error values were then subtracted from the calculated daily volume for each day.

Contamination on the Fiscal ultrasonic meter transducers has caused the meter to read erroneously. The pipework and meter were cleaned to prevent the issue from reoccurring. It is recommended considering additional liquid filtration on the propane injection line. Consideration should be given to continuously monitoring, recording and time/date stamping the diverter valve position in order to ascertain if the system was recirculating or flowing to the distribution network. This would result in easier analysis if measurement errors were to occur again.
